NORTHFIELD #7 & #8 PLANER

TECH TIPS #1

July 26, 2001

TO ALL NORTHFIELD #7 & #8 PLANER OPERATORS:

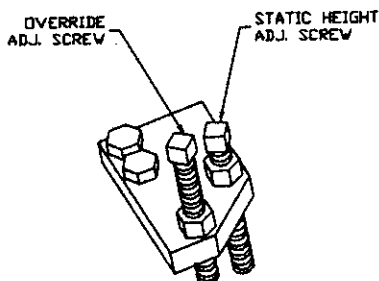
There has always been some confusion on how the chipbreaker has to be set. There are two 3/8" square head set screws on each end of the chipbreaker bar. The screw on each end that is closest to the chipbreaker assembly is the static height adjuster. The screw on each end that is furthest from the chipbreaker is the override adjustment. The static height adjusting screws sit on the machine side frames and are the ones to set the height of the chipbreaker .020" above the cutting circle of the knives. The overrides are the screws that contact the sectional infeed roll bearing blocks and cause the chipbreaker to be lifted when the sectional infeed roll senses an excessively heavy cut coming. If the sectional infeed roll did not lift the chipbreaker assembly, the incoming

wood would hit the steel back plate and drive the chipbreaker into the cutterhead, destroying the knives and damaging the cutterhead. Because the overrides are set approximately 1/16" above the sectional infeed roll bearing blocks, the sectional infeed roll MUST BE SET before the chipbreaker is set.

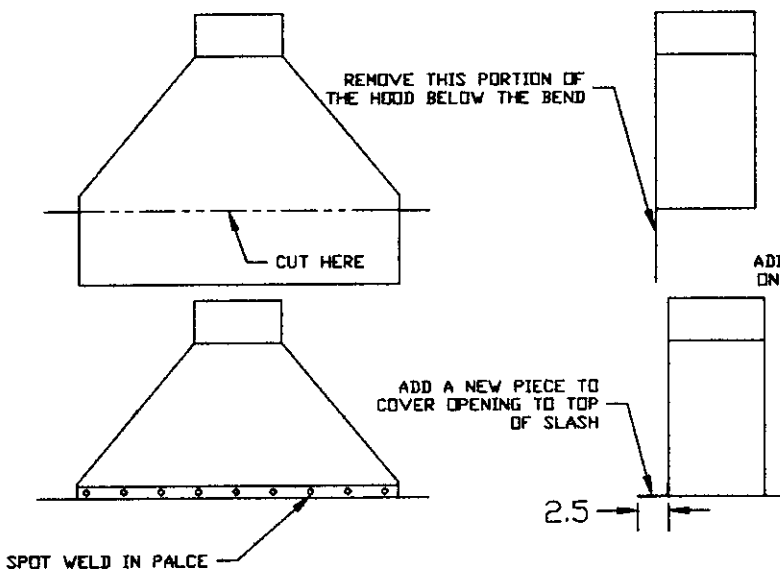
DUST COLLECTION IMPROVEMENTS ON OLDER NO. 7 SURFACER MODELS

On machines built in the 1960's and 1970's, the addition of an infeed sheet steel chip deflector can greatly improve chip collection through the shavings hood. These early machines had a short deflector that hung down from the shavings hood. The addition of an infeed chip deflector that bolts to the inside of the cast iron top sash and drops down in front of the chip breaker improves the air flow through the cutterhead window formed by the chipbreaker toe tips and the pressure bar shoe. The short deflector that was part of the shavings hood, should be cut off and a horizontal piece of sheet metal added to the shavings hood to seal the front of the hood to the top of the top sash.

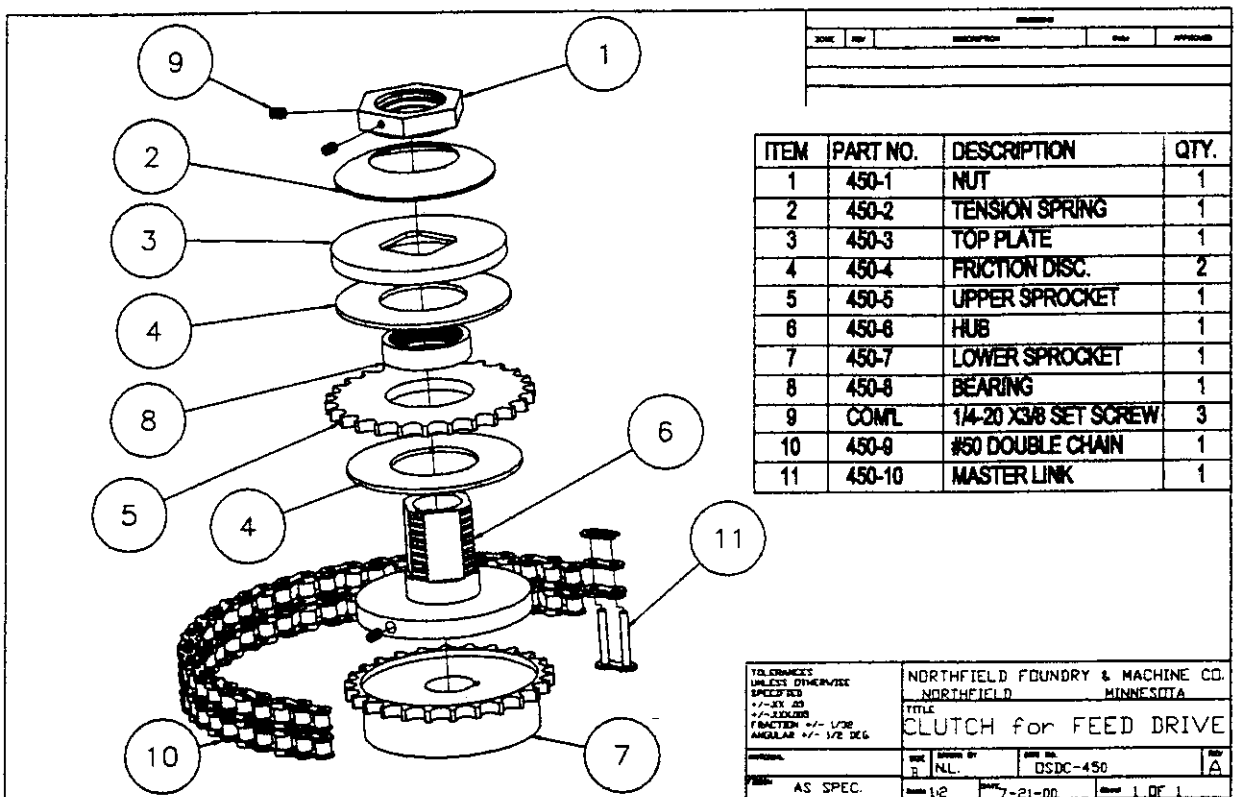
The overload clutch on top of the main gear reducer has 2 functions. First to protect the drive system in an overload condition, and second to act as a universal joint to keep the vertical drive shaft from binding when the lower roll cam shafts are actuated which shifts the vertical drive shaft back and forth slightly.
