BANDSAW UPPER WHEEL BRAKE PLATE ALIGNMENT

Northfield Foundry & Machine Company

March 2003

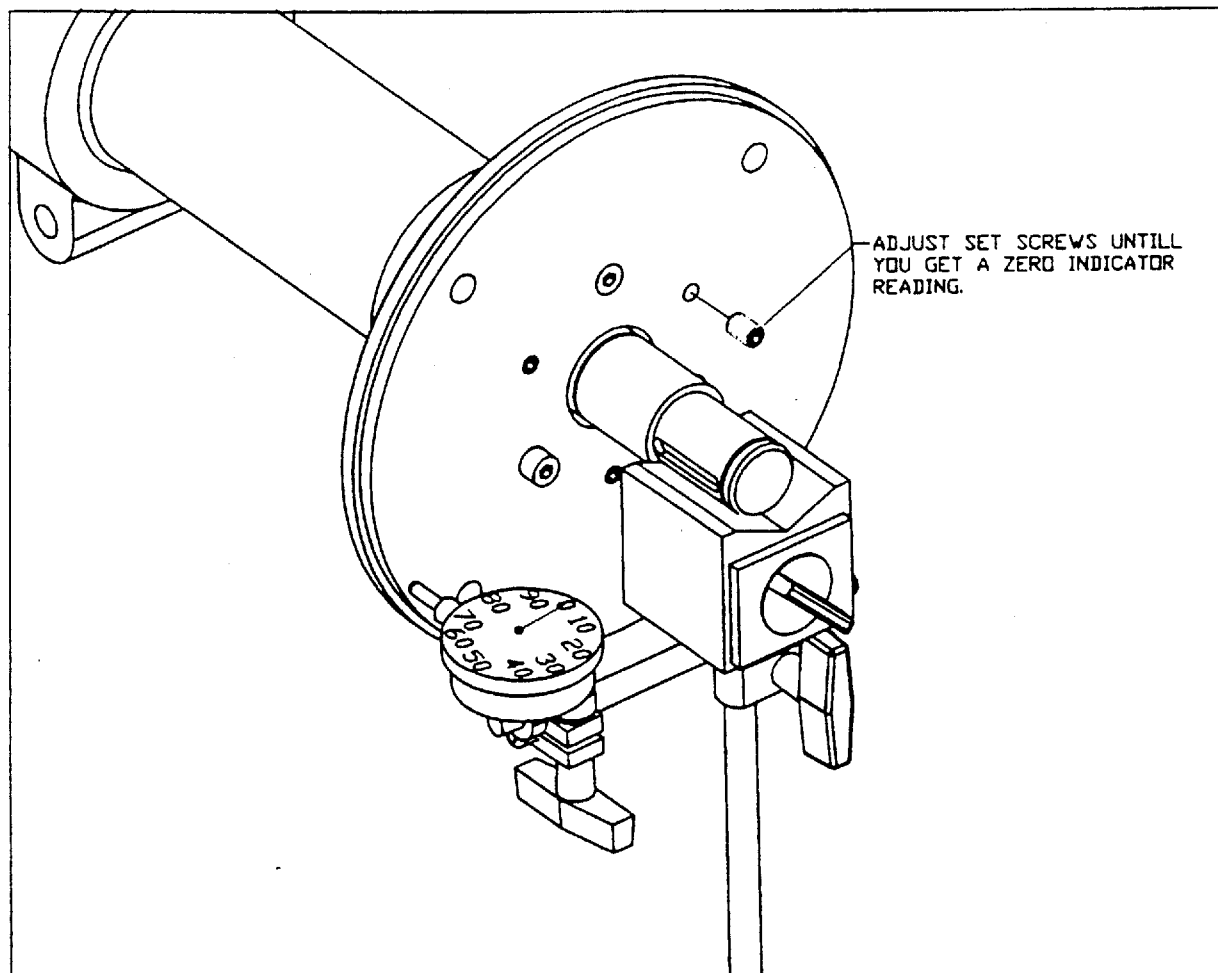
If your upper wheel automatic electric brake is experiencing excessive brake chatter after you have replaced the rotating friction discs and or reset the magnet gap, try the following procedure. Your problem may be that the cast iron adapter plate that the brake assembly bolts to, is not perpendicular to the upper wheel shaft.

1. Shut off electrical power to the bandsaw, observing lockout/tagout procedures, release the blade tension and remove the blade from the wheels.
2. With the blade removed, grasp the upper wheel rim at the 9 & 3 o'clock positions, and check for any mechanical looseness caused by bad bearings, oversized bearing bores in the upper quill, undersized bearing journals on the upper wheel shaft or loose or missing bearing locks or covers. If any of these conditions are present, they will have to be repaired before proceeding.
3. With the brake and splined hub removed from the rear of the upper quill assembly, rig a dial indicator per the drawing off of the rear of the upper quill shaft. Position the indicator so that its plunger can sweep the outer perimeter of the cast iron adapter plate to see if you have a zero reading through a 360 degree sweep.

4. If the dial indicator reading shows that the brake adapter plate is not perpendicular to the upper quill shaft, the plate will have to be squared.

5. Squaring the adapter plate can be done two ways:

A. The adapter plate can be removed and set screws added in between the three existing mounting holes. Drill $17/64$ " and tap 5/16-18 on the bolt circle formed by the three mounting holes, with the set screws positioned equally between the mounting holes. The set screws can then be adjusted to square the adapter plate to get a zero indicator reading.

B. Metal shims can be added in between the adapter plate and the rear end of the upper quill castings. Add shims until you get a zero indicator reading.

6. With the adapter plate adjusted so that it provides a square surface for brake mounting, reassemble the brake to the upper quill, replace the blade and test.
