REPOURING BABBITT THROATS IN OLDER BANDSAW TABLES

Older Northfield Bandsaws, approximately pre 1955, did not have a replacable aluminum table insert. The throat plate was molten babbitt poured into the table opening. The following instructions will allow you to refurbish your older saw throats.

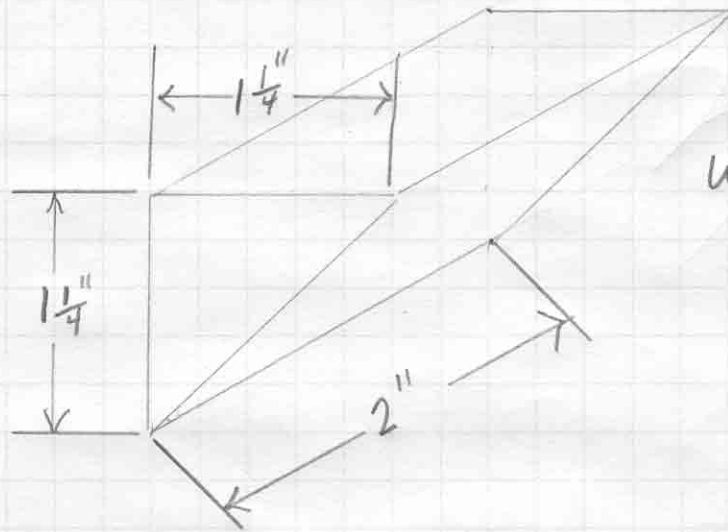
WOOD CORE
DETAIL

5. Cut a piece of wood 1-1/4" square x 2" long. Cut a 45 degree angle on the 1-1/4" corner to corner along the 2" length. The purpose of this wood core is to provide clearance for the blade when the table is tilted.

WOOD CORE STABILIZED
WITH BAR OF STEEL
FROM TABLE EDGE

BLADE SLOT IN TABLE

6. With the table slot facing you place the wood core point down on the left hand side of the 1/8" steel bar stuck in the blade slot. Stabilize this piece with a bar of steel to keep it standing upright and also to provide enough down pressure so that the molten babbitt will not float it up.

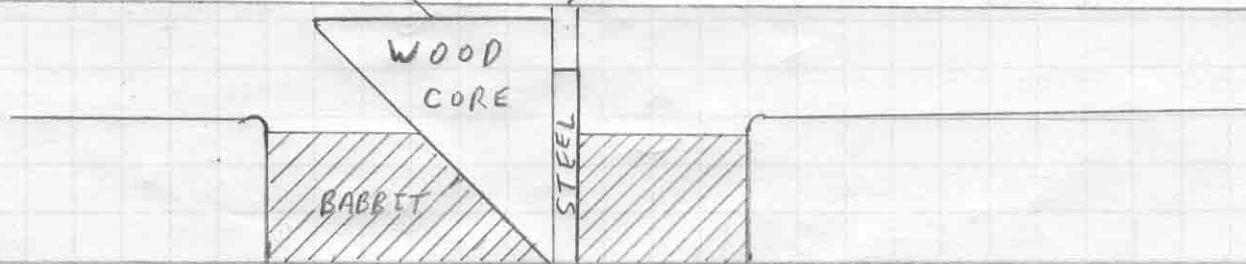
↑
TABLE
TOP

STEEL PLATE

LOOKING AT BOTTOM OF TABLE

3. Lay cast iron table face down on a flat steel plate.
4. Insert a piece of 1/8" x 1" x 4" cold finished steel into the blade slot so that it projects 2" into the throat hole.

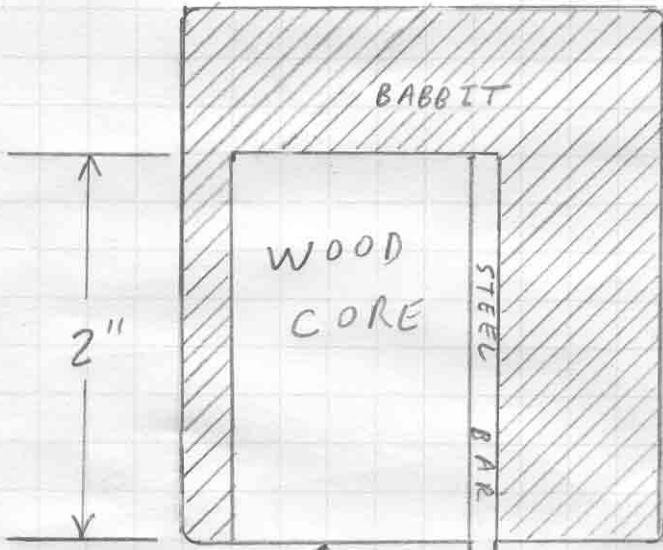
CORE FLUSH TO
FRONT OF THROAT HOLE

BLADE SLOT

FRONT OF TABLE
